# Ian McDowell - WotsWot foam-e repair, Update

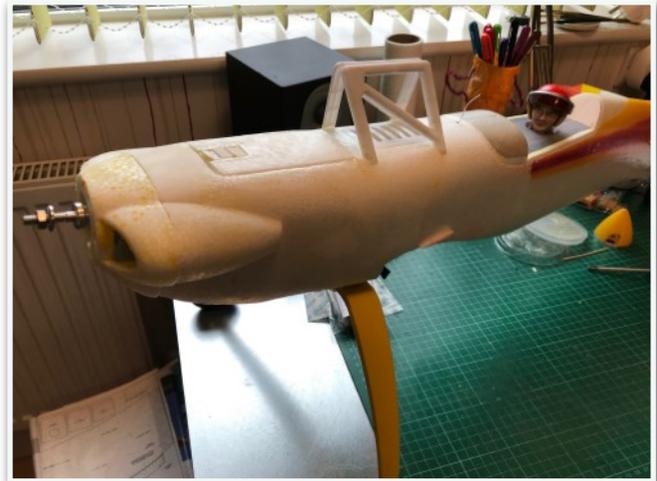
After a bit more filler and a lot of rubbing down, she was cleaned up with meths. The typical crocodile skin resulting from steam treatment was, and remains evident, but the bits that concerned me were very fuzzy patches when the foam had just become hairy from the abuse.

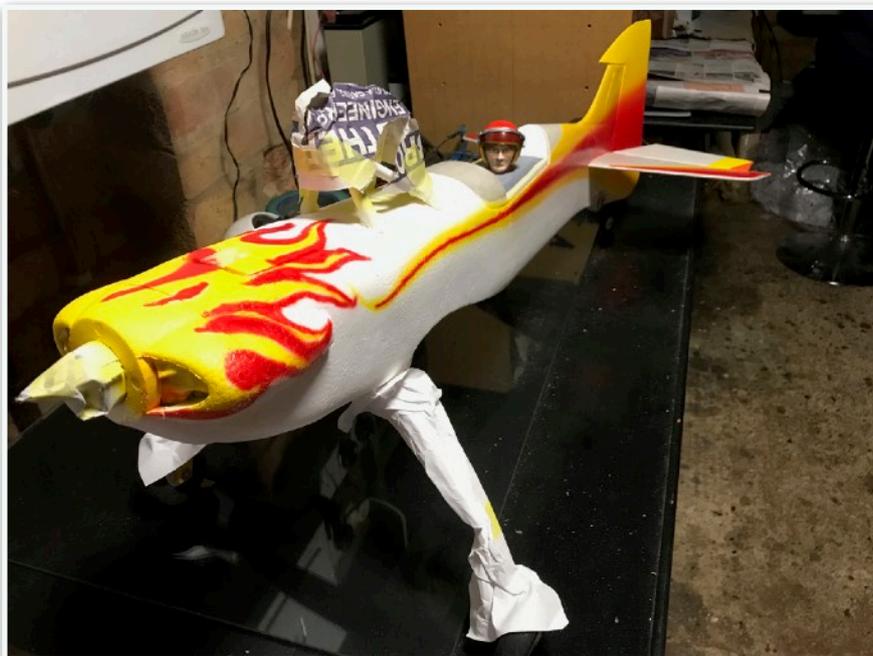
Previous attempts had not been terribly robust, with paint regularly flaking off. So I tried a little harder to prepare the surface this time.

The previous repair had been sprayed with Vallejo Premium acrylic paint, followed by a coat of Wilco 'Ultra Tough' quick drying varnish for protection (!). I assume the varnish is polyurethane based as it yellows relatively quickly.

This time the same varnish was applied over the forward part of the body to stabilise the surface and prime it ready for Vallejo Premium airbrush paint. This was rubbed right back and again cleaned with meths.

She was then treated to Vallejo white primer; a freehand attempt at stylised flames in red and yellow and some lines to join to the red/orange/yellow at the rear of the body, and then Vallejo gloss varnish over the whole. The gloss worked well over the layer of colour. Less successfully over the white filled areas.

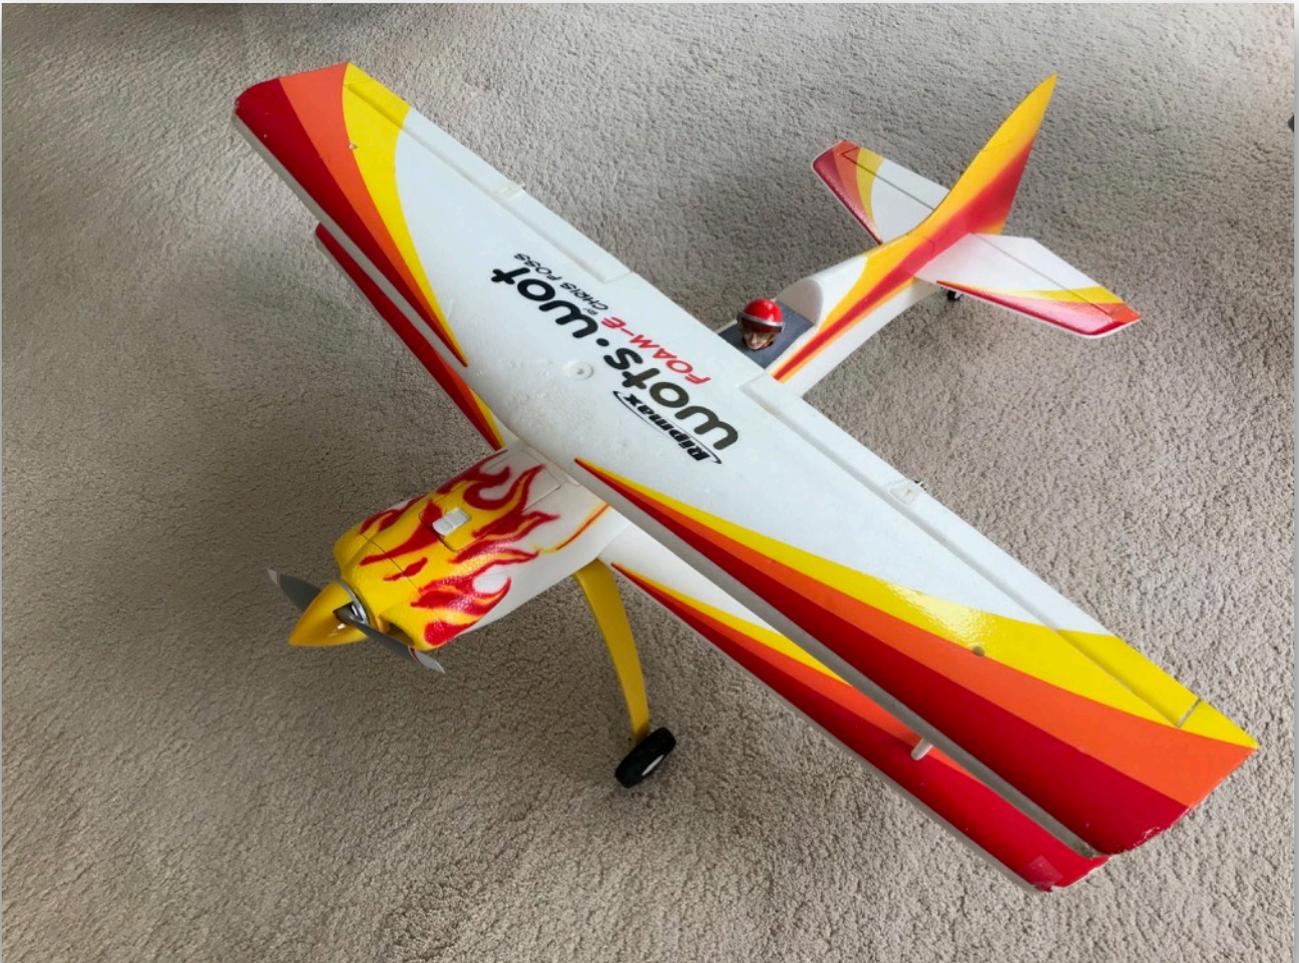
Putting her back together, I discovered some more hairline breaks in the foam - on either side of the fuselage, off the lower wing mounting point. These have been carefully prised open, holes bored along their length and glued with 15 min epoxy. I added a cocktail stick on each side, inserted close to a right angle with the cracks, also glued with 15 min epoxy.

And finally, a new spinner plus the ragtag replacement windscreen.
