Photos of the SBach re-build, 4

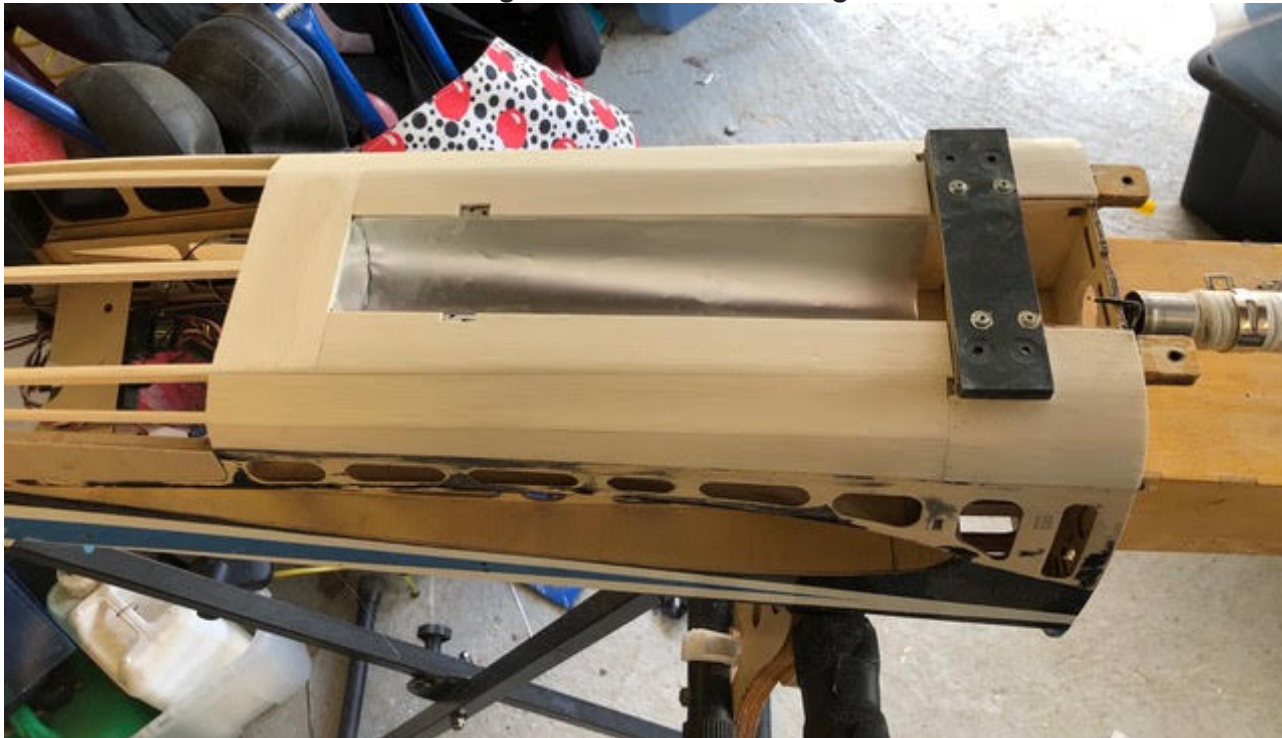
Longerons and balsa sheeting added. The original didn't have the underside sheeted but I decided to do it to give some more strength around the can tunnel:

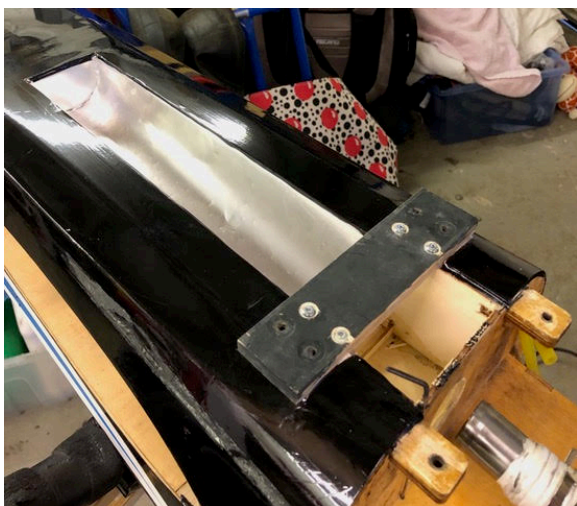
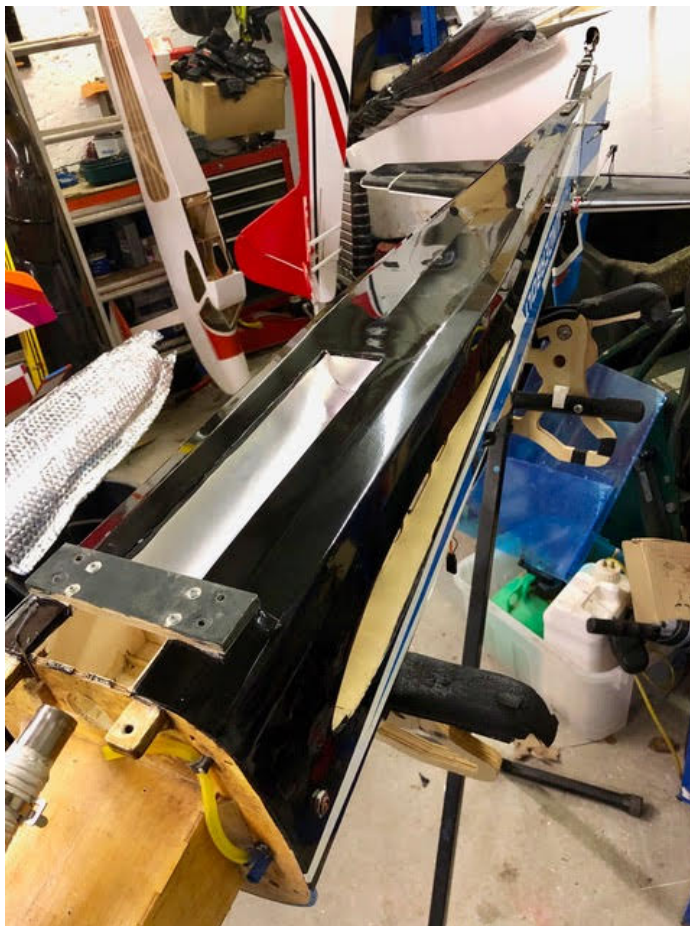
Covering done:

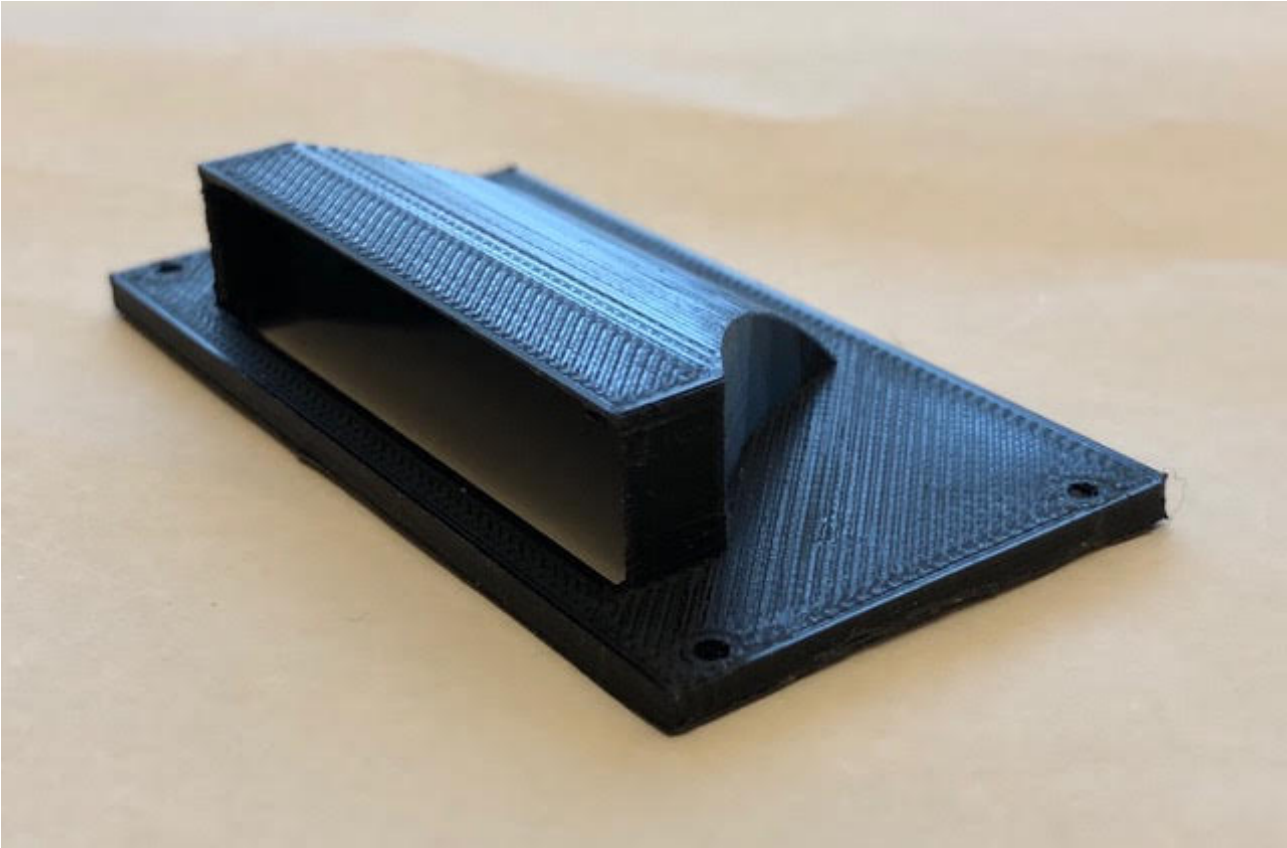
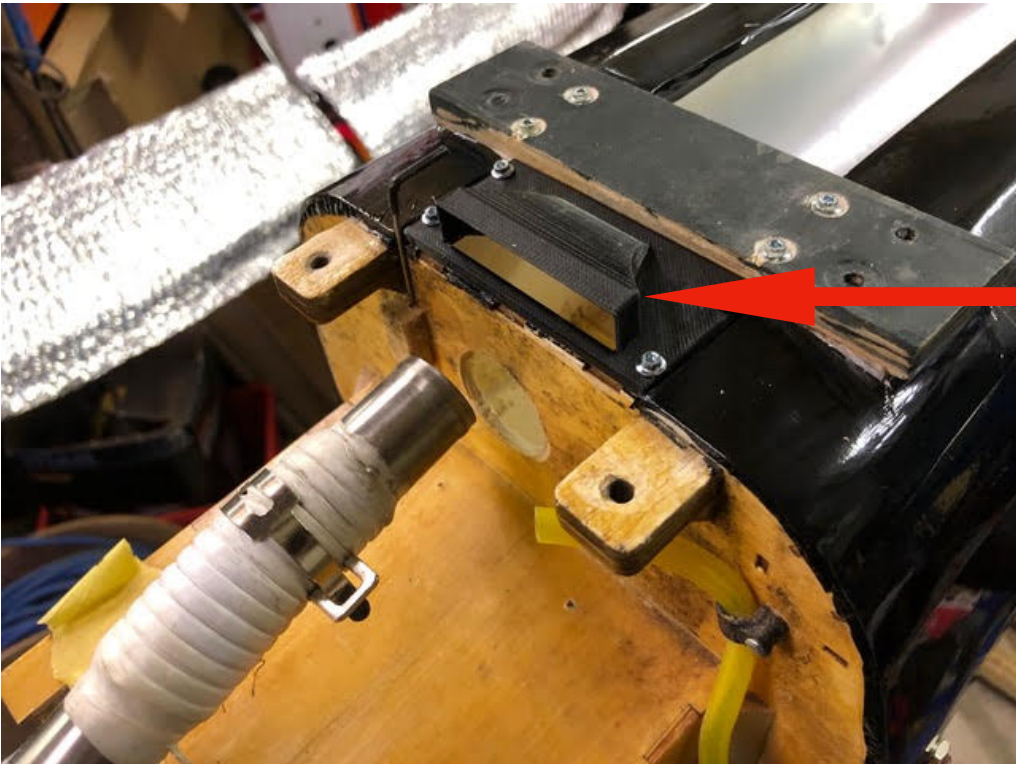
And a 3D printed intake made up:

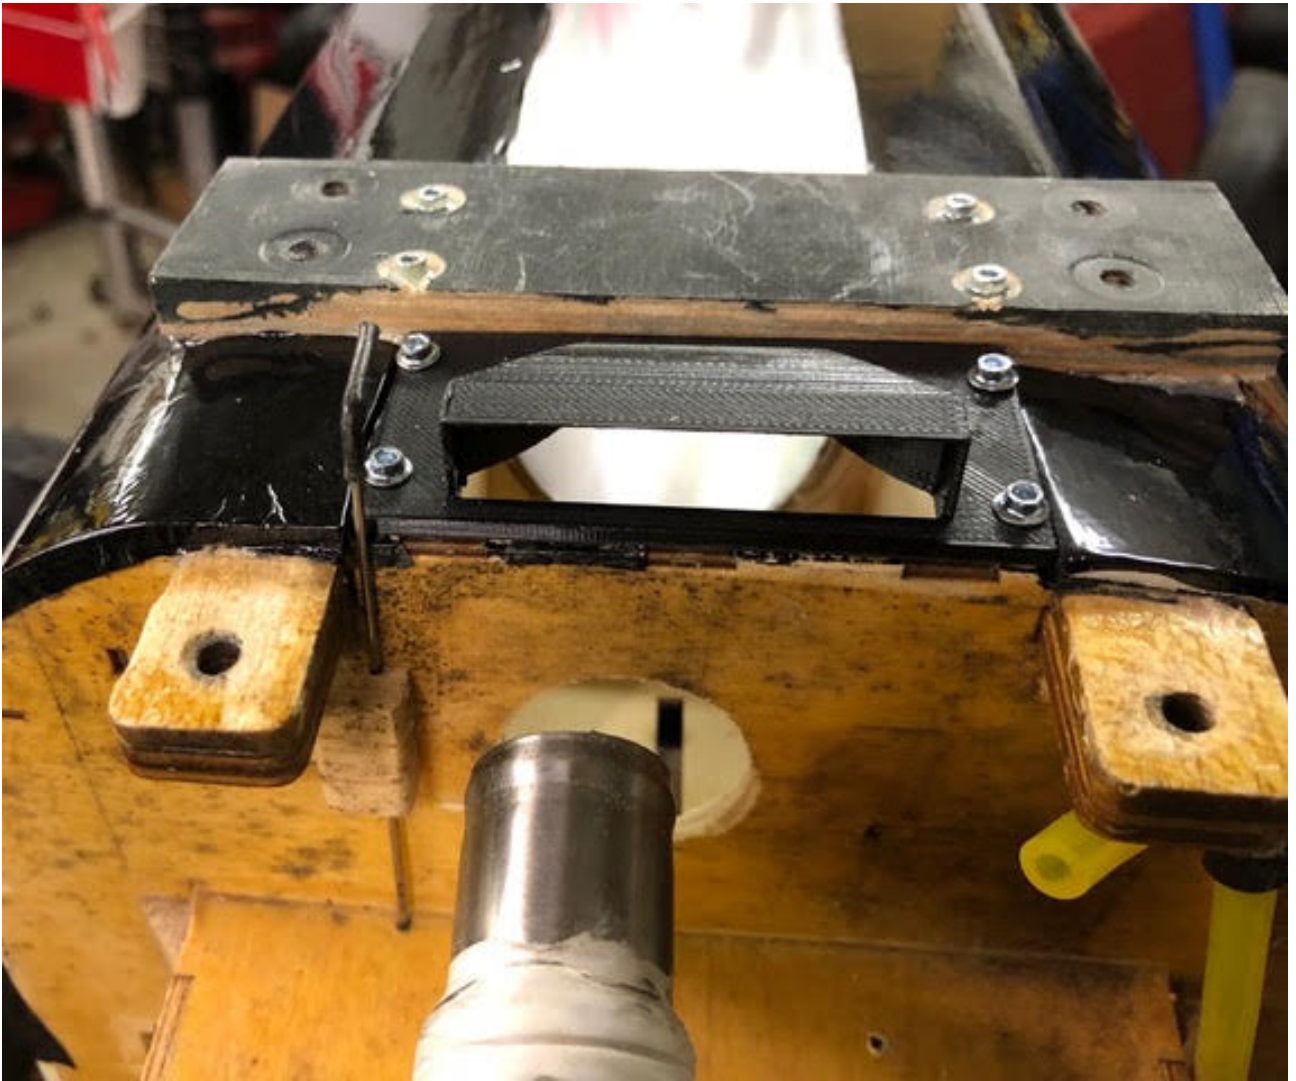
And fitted to force cooling air down through the can tunnel.

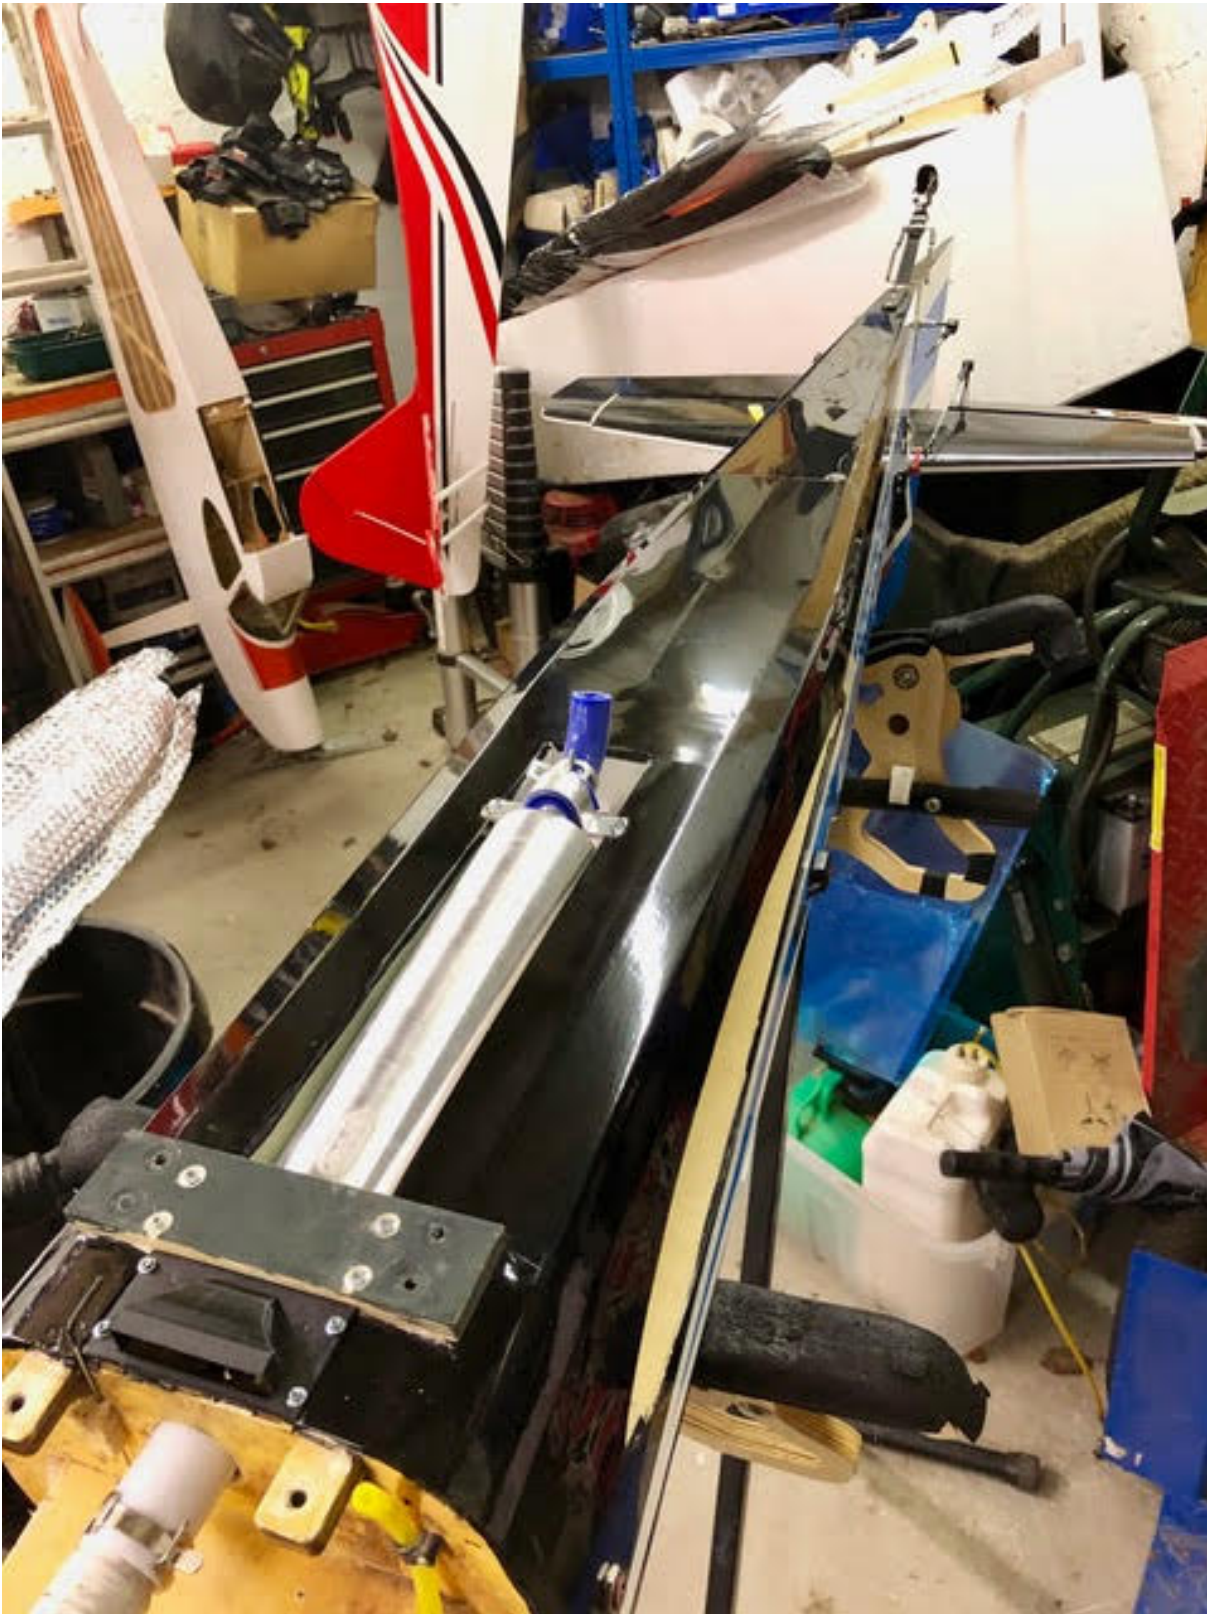
Main repair work to fuse completed and I must say that I'm quite pleased with the result!
