SIG Rascal 110" renovation, 2

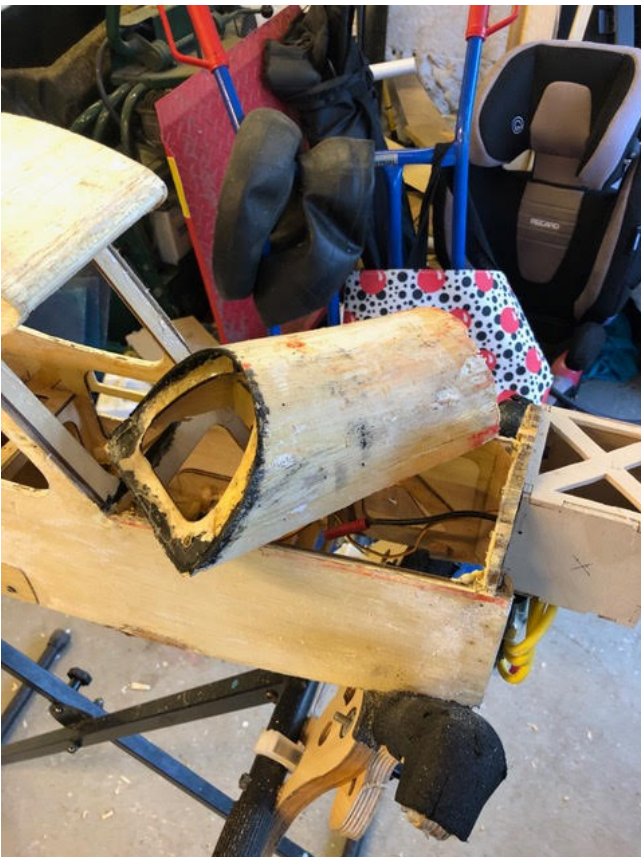
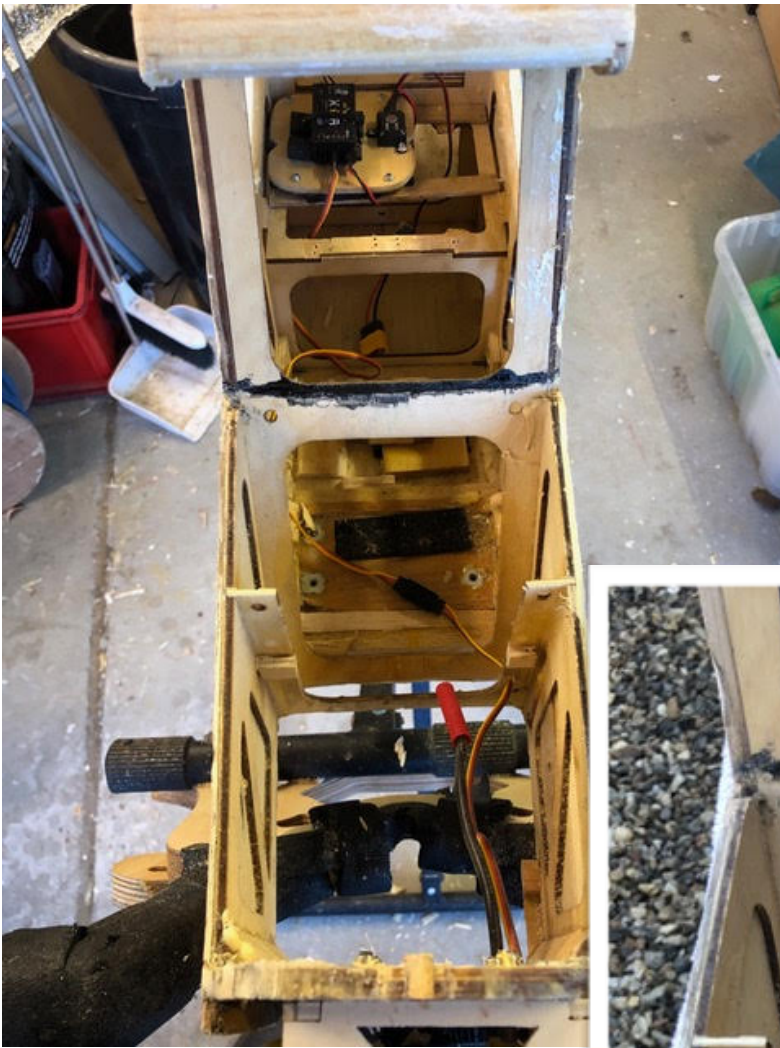
I had decided that the means of access to get the batteries in and out needed to change so out with the knife and off with the top half of the fuse. Just as well really as the balsa in this area was more than a bit tired.

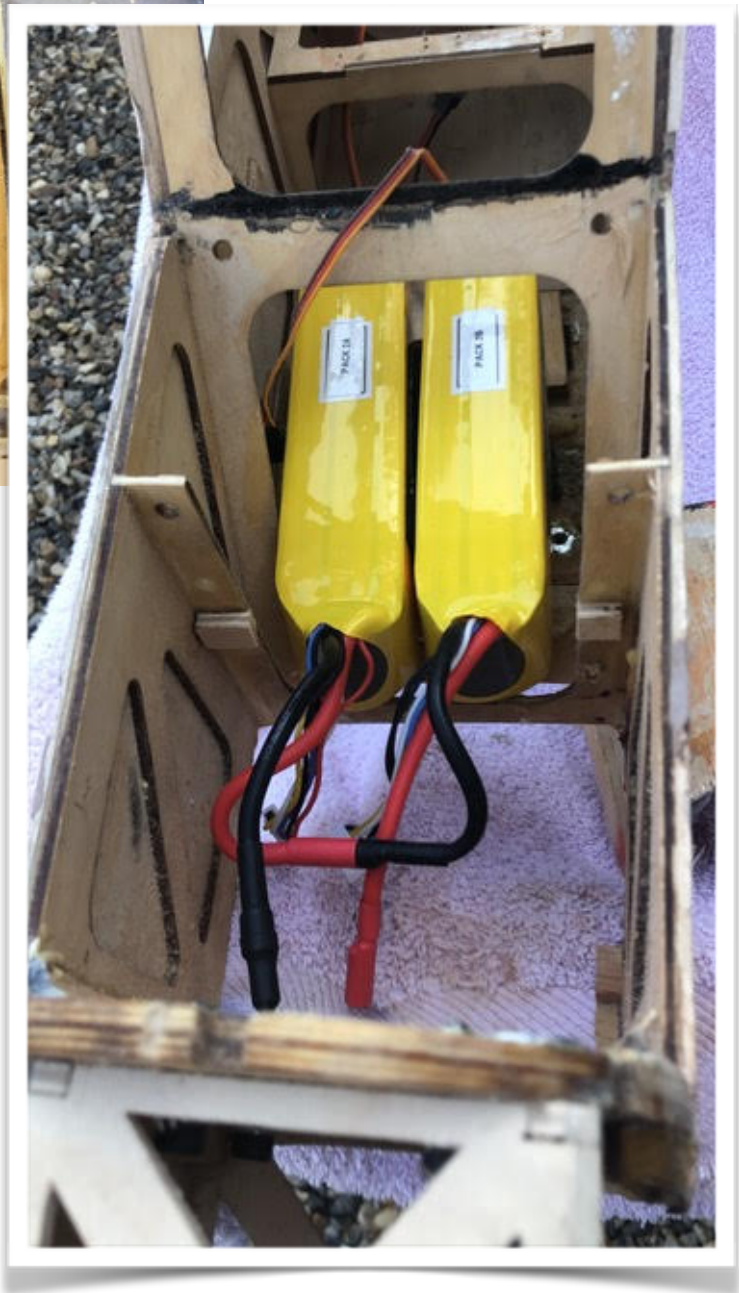
This now gives me a nice opening through which the 2 x 5s 5000mAh batteries can be passed

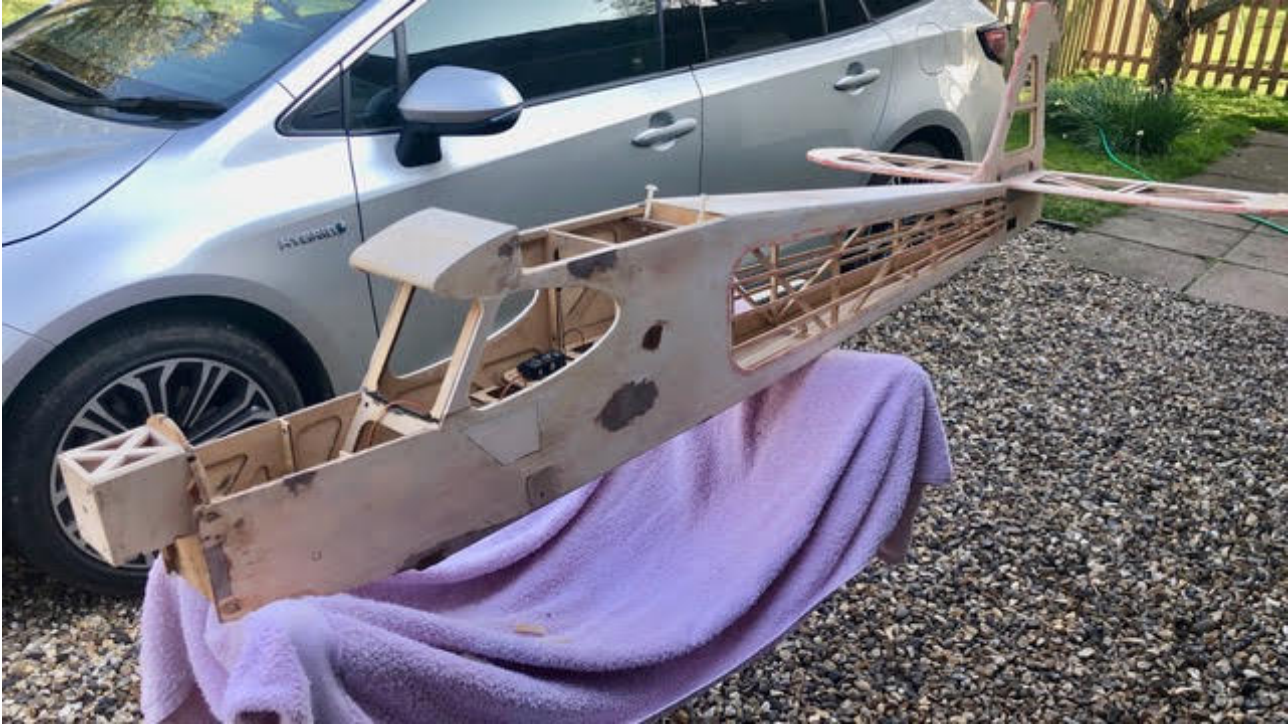
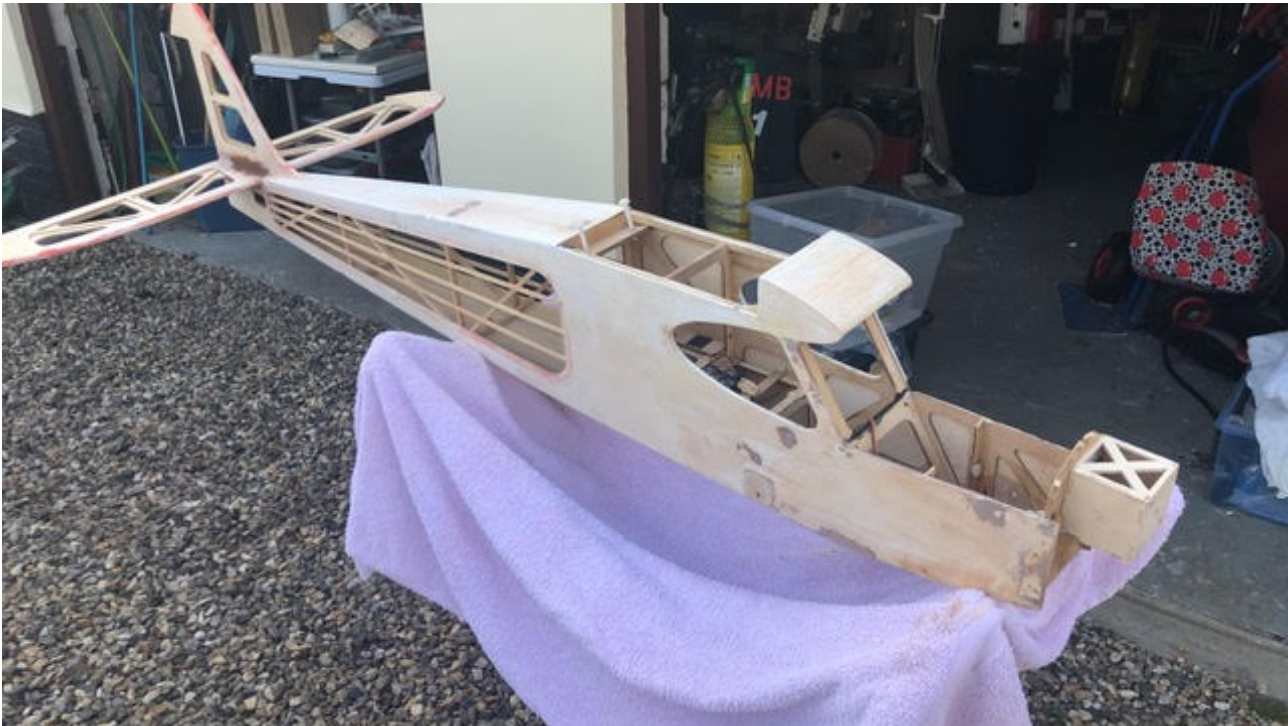
I then spent the best part of 3 days filling and sanding, filling and sanding and so on, until I got to this stage

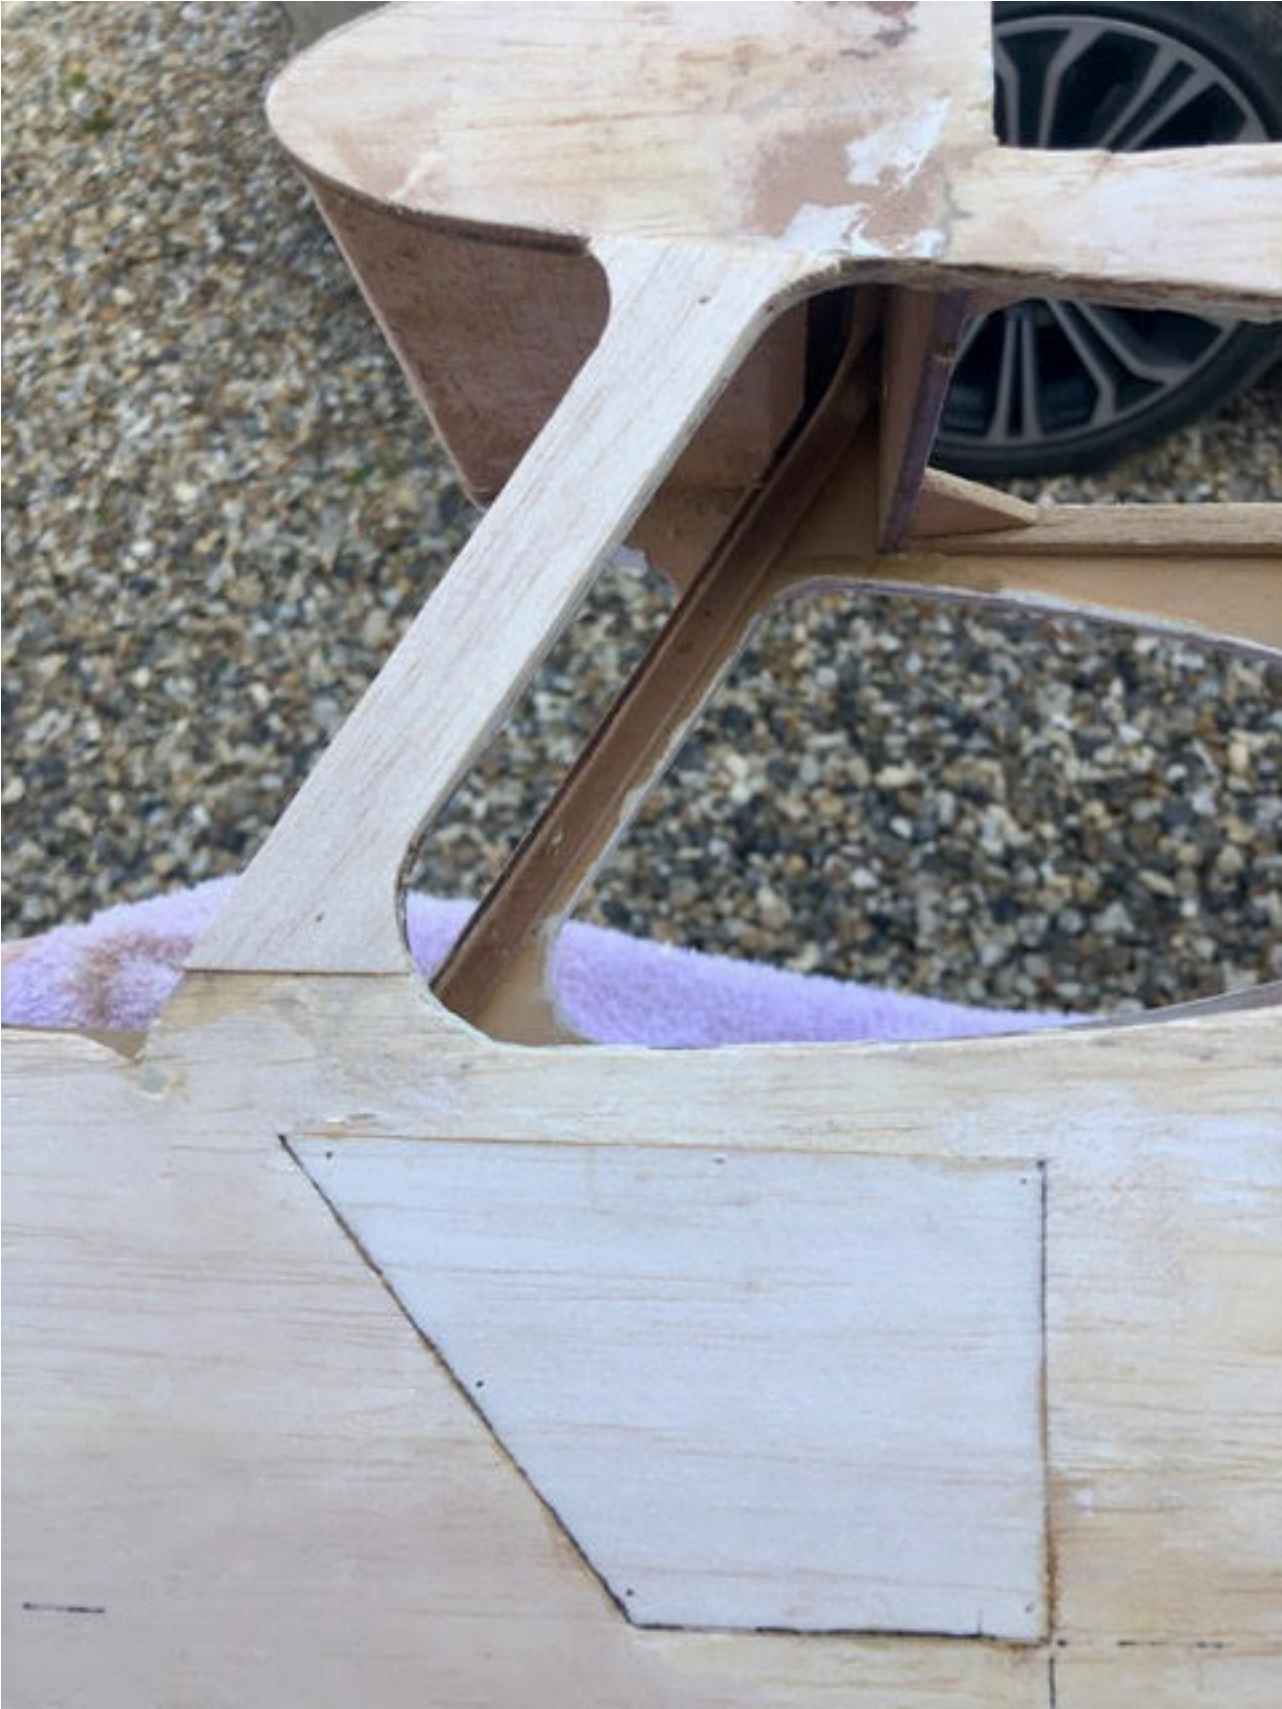
Not just filling but cutting out and replacing balsa

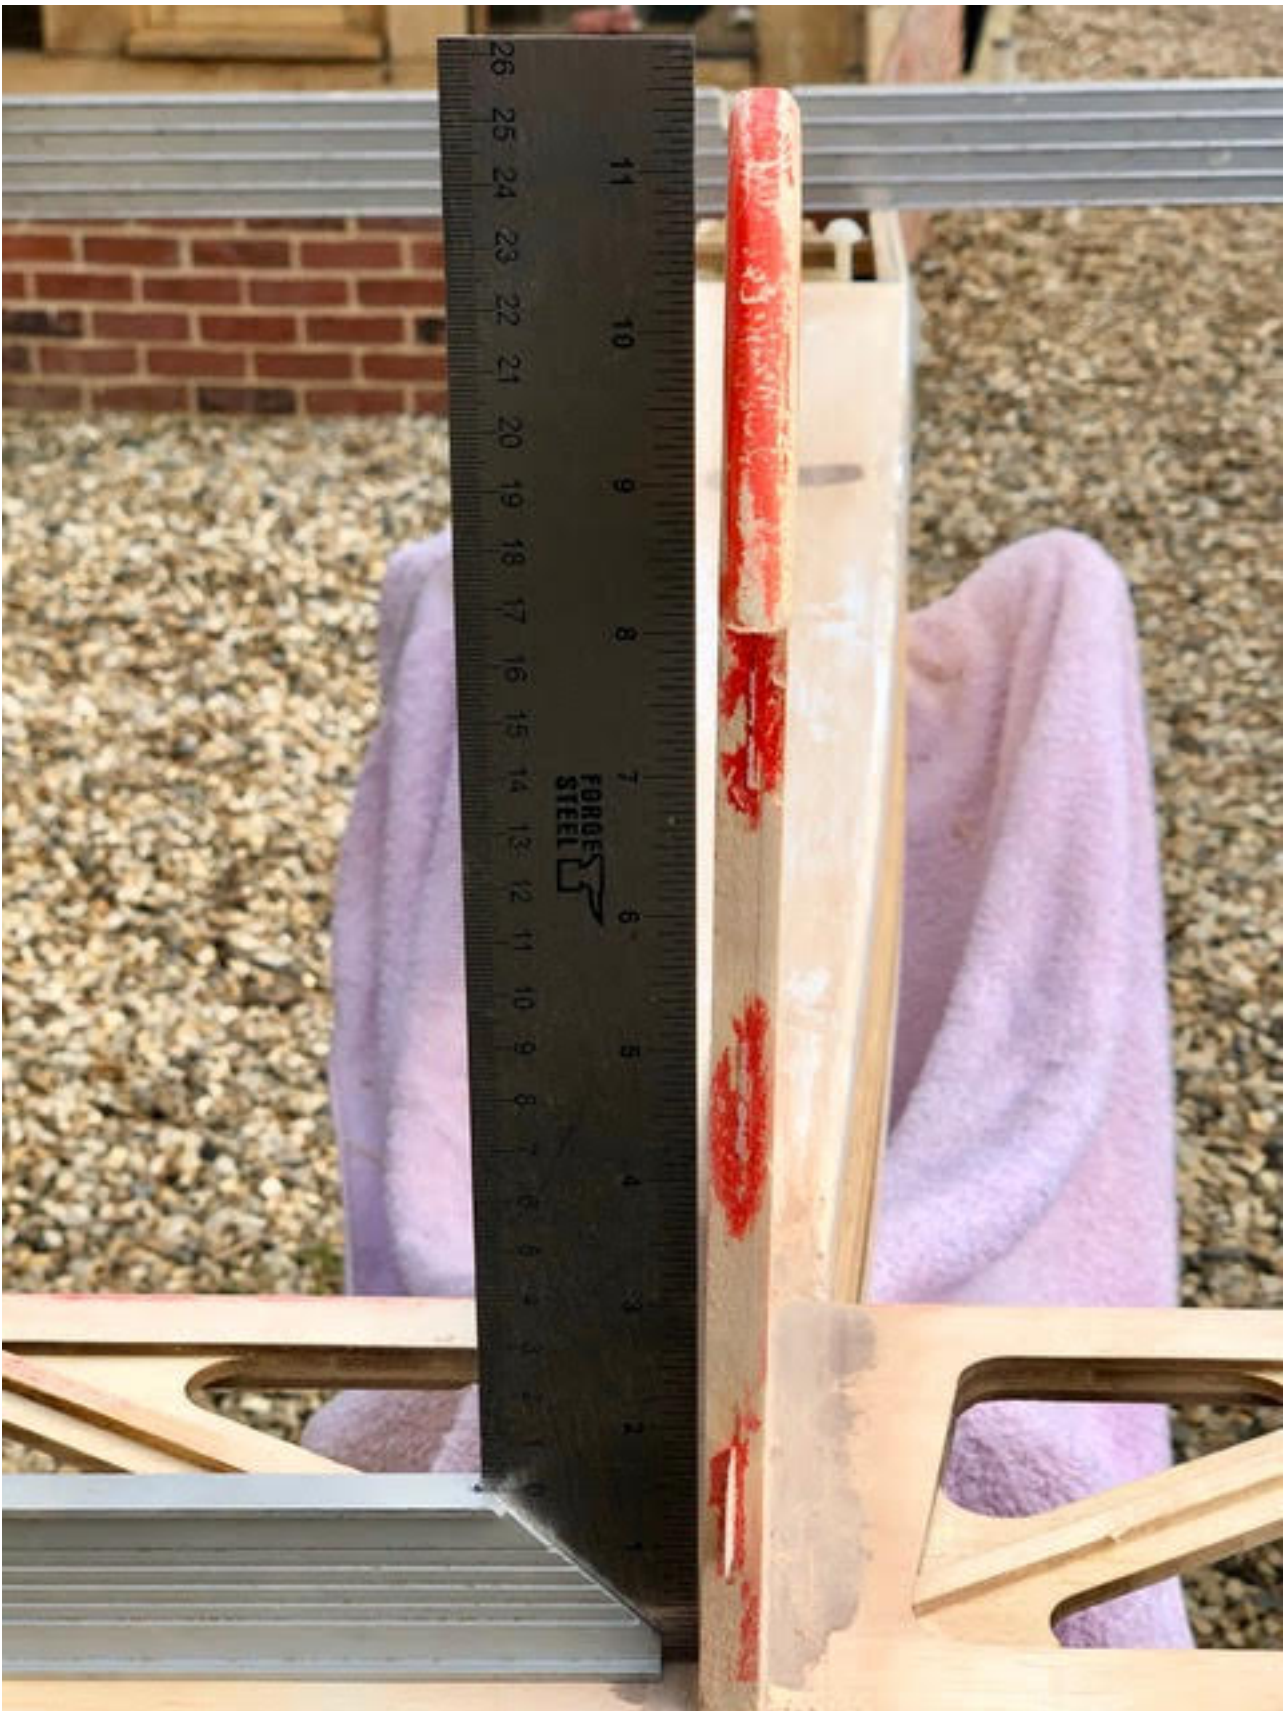
It was then that I noticed the fin wasn't vertical (which would explain why I had to dial in some trim when I flew it).

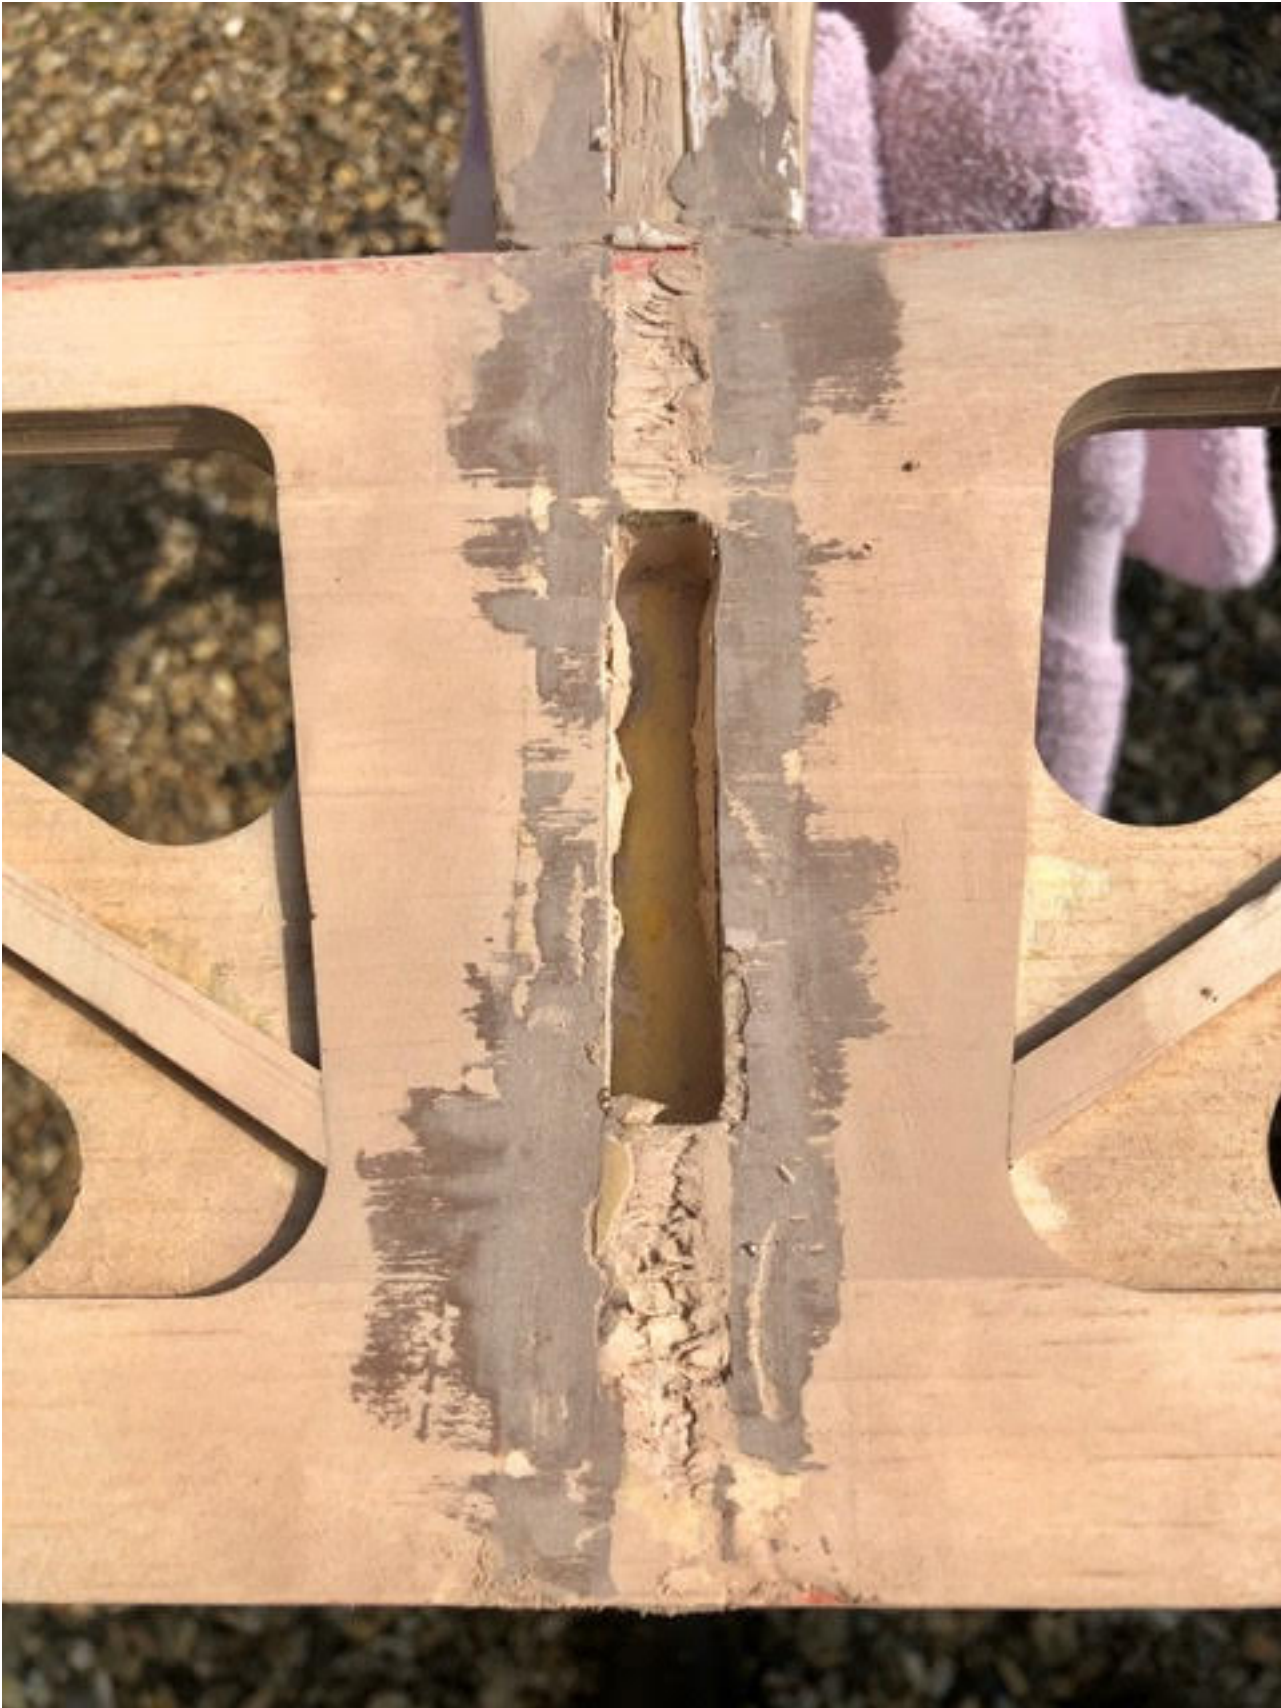
What to do? I had spent quite a while filling the poor balsa around the junction of fin to tailplane so I was thinking maybe steam or wet and bend the fin vertical. In the end I did the 'correct' thing and cut the fin away from the fuse.

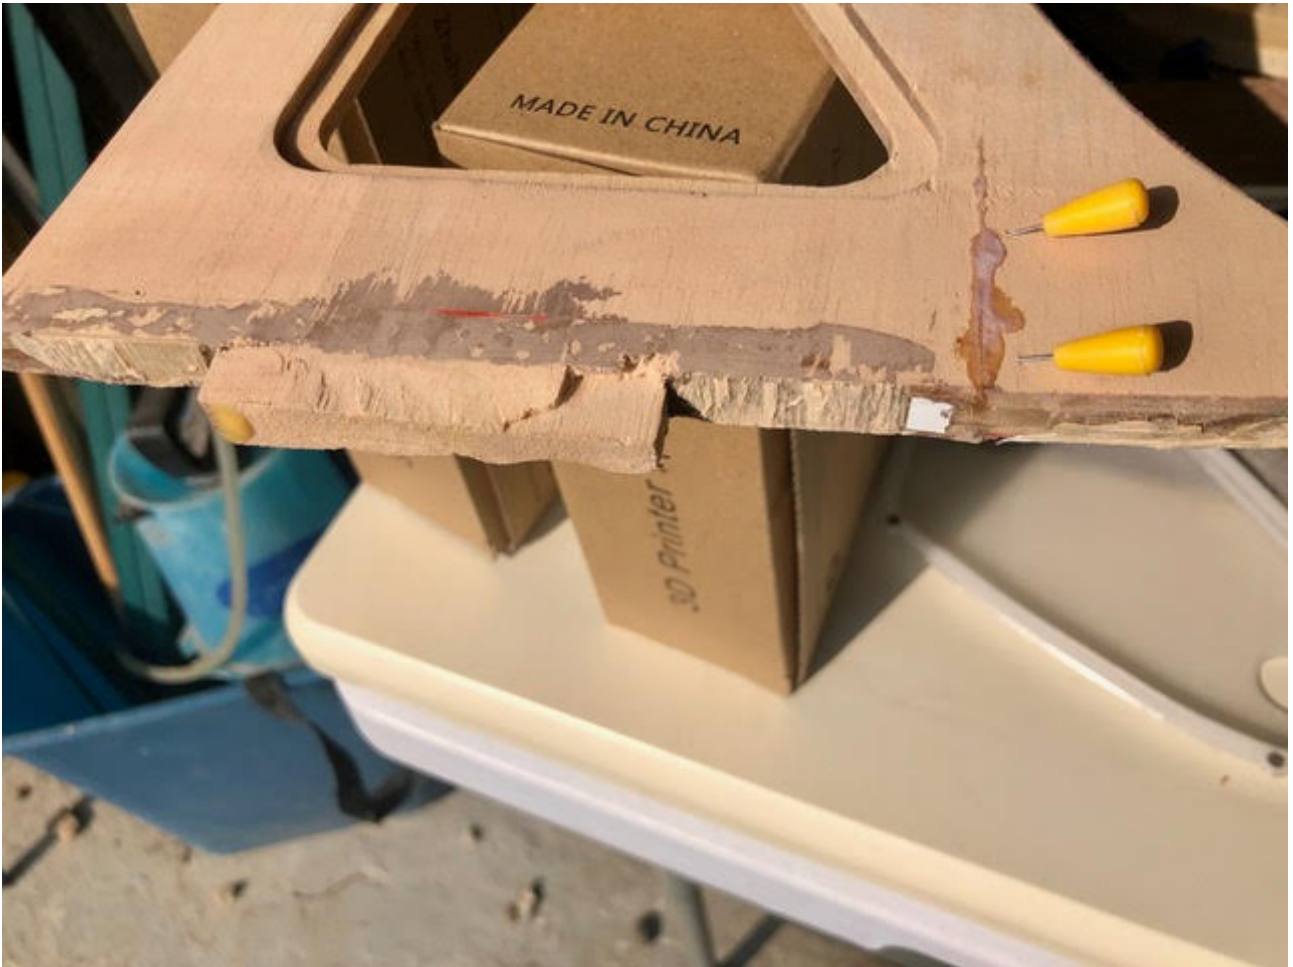
I was glad that I did as there was a split in the fin which some superphatic fixed.

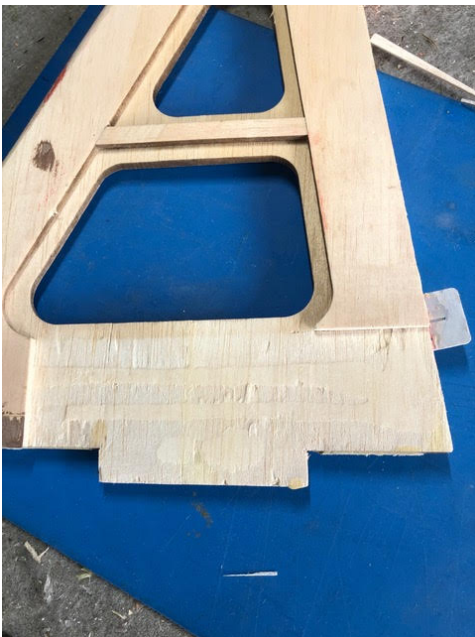
But I wasn't happy with the way that SIG had constructed the fin as all 3 layers were formed from vertical grain balsa. So I removed a section from both the outer skins and replaced them with balsa with the grain running horizontally. This also gave me a better 'tongue' for sticking back in the fuse.
